Southern Home Inspection Services  
4491 Tarragon Ave  
Middleburg, Florida 32068

1835 Quebec Court  
Middleburg, Florida 32068

06:45 June 25, 2019

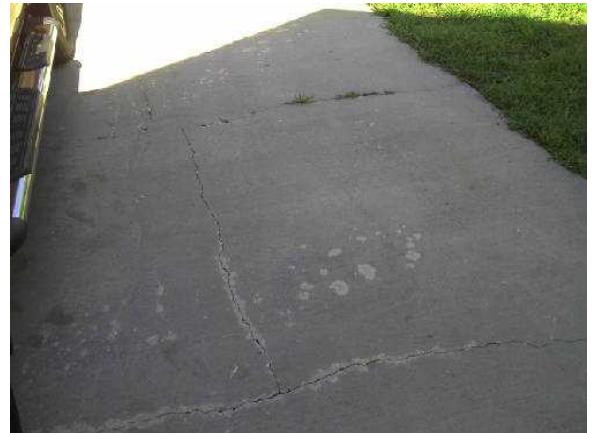
1. ☒ ☐ ☐ ☐ ☐ Driveway: Concrete - Various Cracks

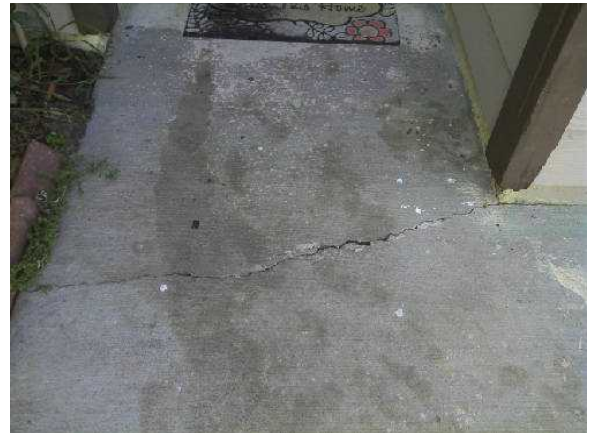
2. ☒ ☐ ☐ ☐ ☐ Walks: Concrete - Cracked

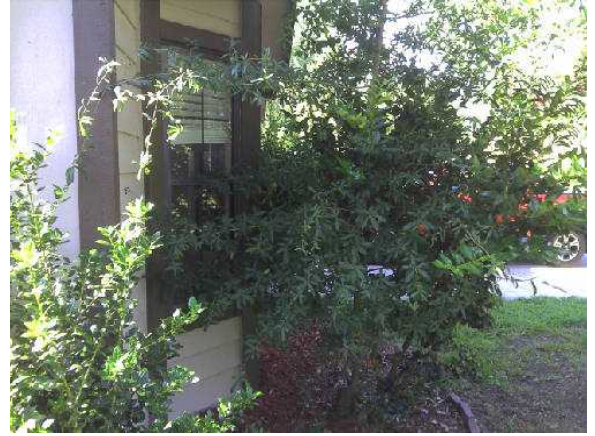
4. ☐☐☐☒☐ Vegetation: Trees - Trees & Shrubs planted too close to structure, removal is required. Cut & remove as needed.

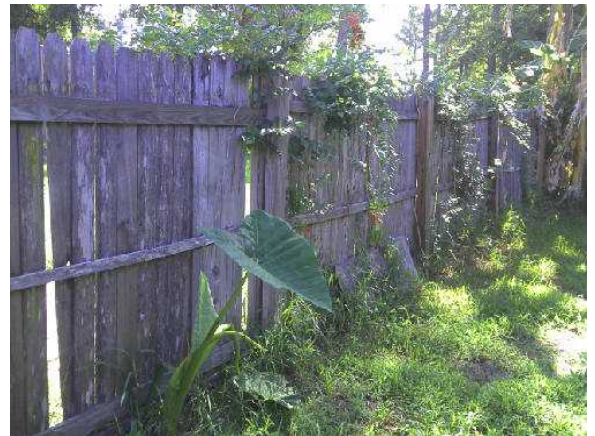
5. ☐☐☐☐☒ Fences: Wood - Damaged. However, adjacent Homeowner said they plan to replace & install new fencing in August.

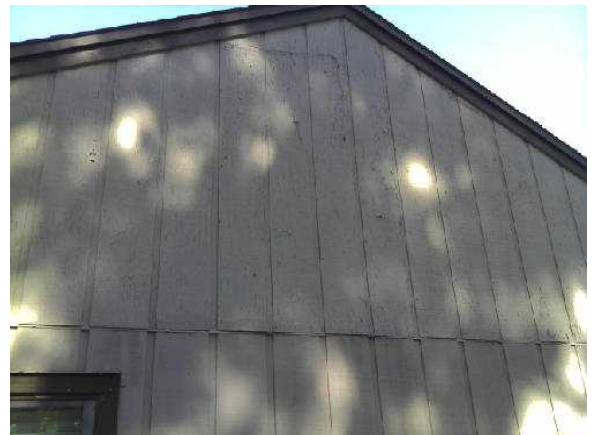
1. ☐☐☐☒☐ Type: Cement Fiber and Wood Panels - East Gable wood paneling exhibits blister & peeling. Recommend further evaluation for repairs & replacement as needed.

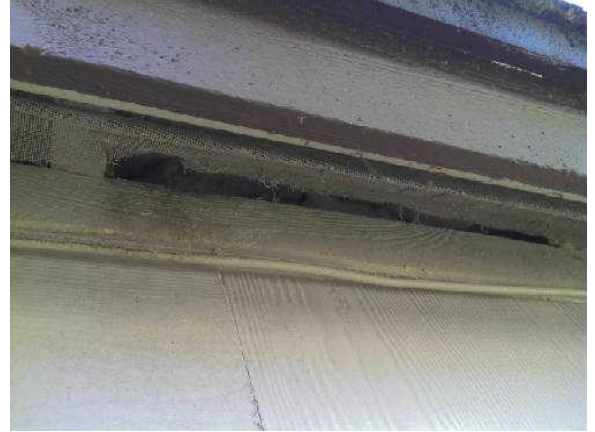
3. ☒ ☐ ☐ ☐ ☐ Fascia: Wood  
4. ☐ ☐ ☐ ☐ ☒ Soffits: Screen - Soffit screening patio side needs repair. Other areas may require repair & replacement as needed.

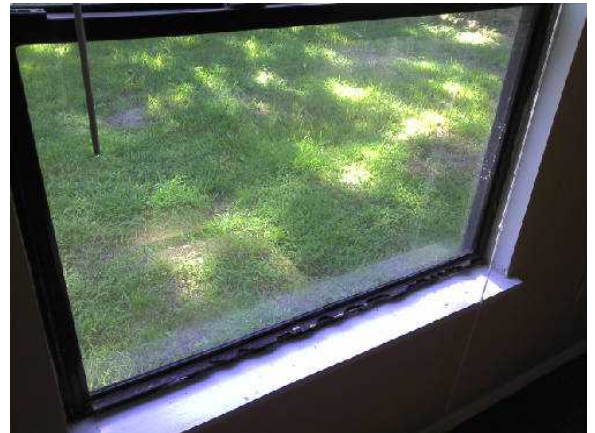
5. ☒ ☐ ☐ ☐ ☐ Door Bell: Hard wired  
6. ☒ ☐ ☐ ☐ ☐ Entry Doors: Metal  
7. ☒ ☐ ☐ ☐ ☐ Patio Door: French door  
8. ☐ ☐ ☐ ☐ ☒ Windows: Vinyl double hung - South Bedroom window is damaged & will not open. Other random windows throughout difficult to open or will not open. Recommend further evaluation to determine repairs or replacement as needed.

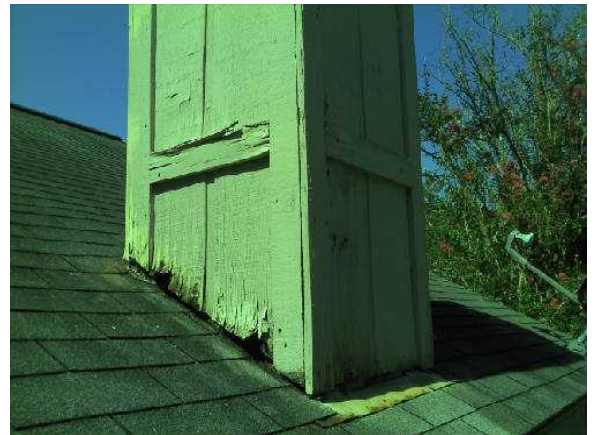
9. ☐ ☐ ☐ ☐ ☒ Chimney: Wood Siding - Unable to view interior of chimney due to height. Replace & repair all damage wood and seal all areas to prevent water intrusion.

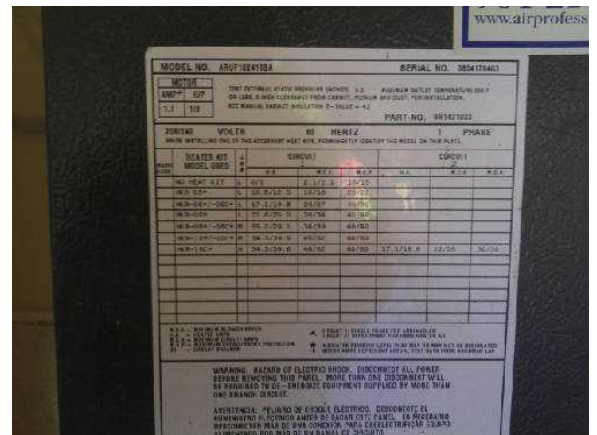
1. ☒ ☐ ☐ ☐ ☐ Heating System Operation: Appears functional, last inspection recorded Oct 2014. Recommend service & routine maintenance for optimum performance.

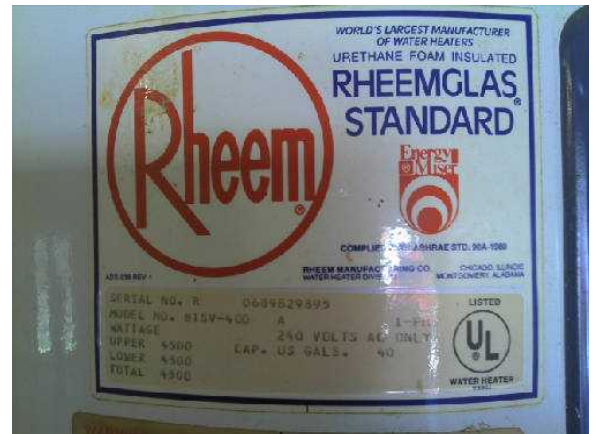
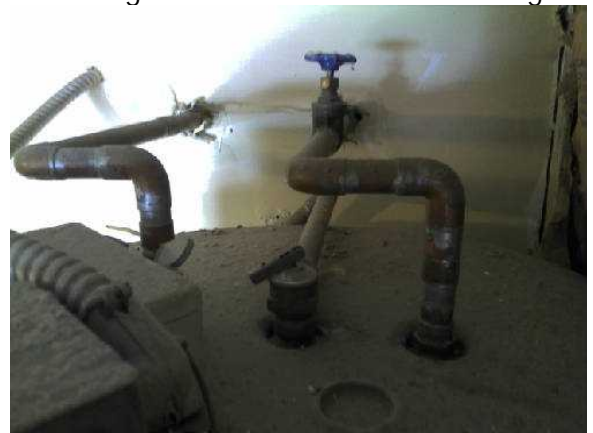
8. Manufacturer: Rheem  
9. Model Number: 81SV-400 Serial Number: 06891329895  
10. Type: Electric Capacity: 40 Gal.  
11. Approximate Age: 30 years, recommend to budget for replacement due to age. Area Served: Whole building  
12. ☒ ☐ ☐ ☐ ☐ TPRV and Drain Tube: Copper

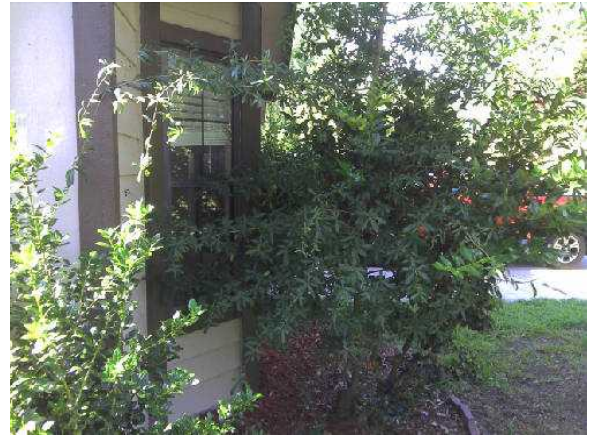
1. Vegetation: Trees - Trees & Shrubs planted too close to structure, removal is required. Cut & remove as needed.

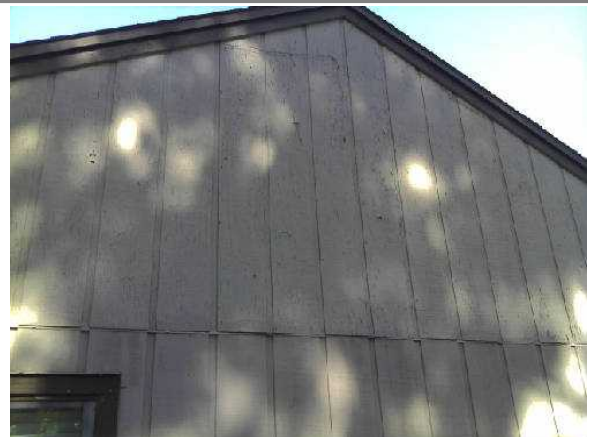
2. Exterior Surface Type: Cement Fiber and Wood Panels - East Gable wood paneling exhibits blister & peeling. Recommend further evaluation for repairs & replacement as needed.

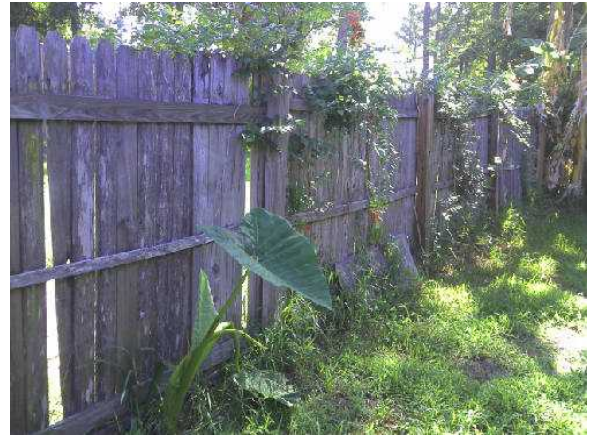
1. Fences: Wood - Damaged. However, adjacent Homeowner said they plan to replace & install new fencing in August.

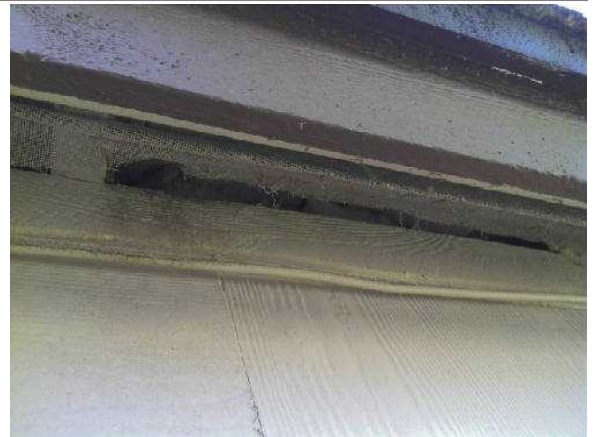
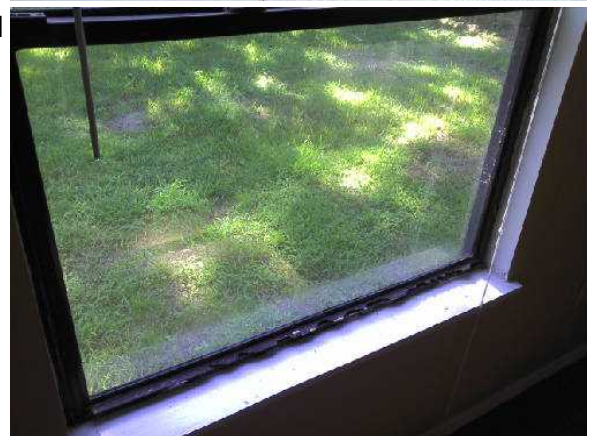
2. Soffits: Screen - Soffit screening patio side needs repair. Other areas may require repair & replacement as needed.
3. Windows: Vinyl double hung - South Bedroom window is damaged & will not open. Other random windows throughout difficult to open or will not open. Recommend further evaluation to determine repairs or replacement as needed.

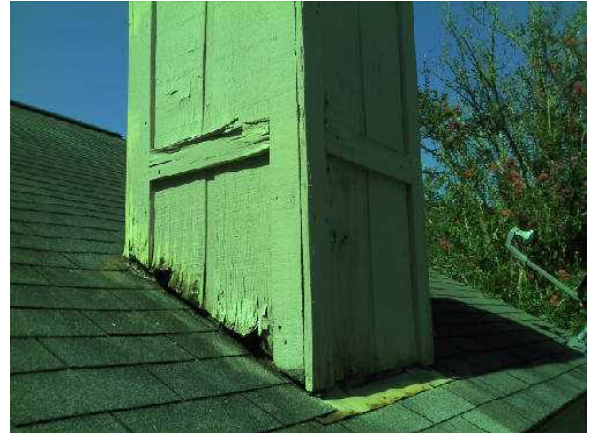
5. North Chimney Chimney: Wood Siding - Unable to view interior of chimney due to height. Replace & repair all damage wood and seal all areas to prevent water intrusion.
