Southern Home Inspection Services  
4491 Tarragon Ave  
Middleburg, Florida 32068

1835 Quebec Court  
Middleburg, Florida 32068

06:45 June 25, 2019

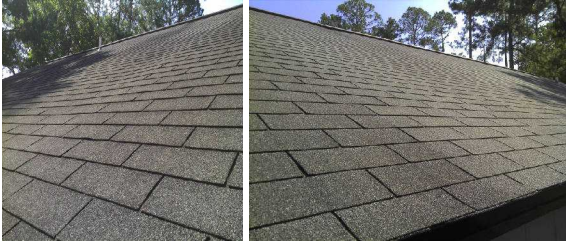
### Main Roof Surface

2. ☒ ☐ ☐ ☐ ☐ Unable to Inspect: 25%  
3. ☒ ☐ ☐ ☐ ☐ Material: Asphalt shingle  
4. Type: Gable  
5. Approximate Age:  
6. ☒ ☐ ☐ ☐ ☐ Flashing: Aluminum  
7. ☒ ☐ ☐ ☐ ☐ Plumbing Vents: PVC  
8. ☒ ☐ ☐ ☐ ☐ Electrical Mast: Underground utilities

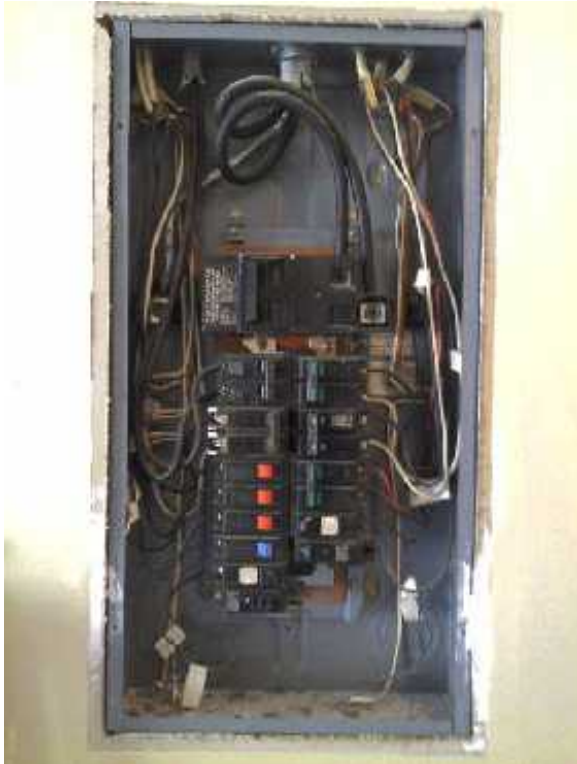
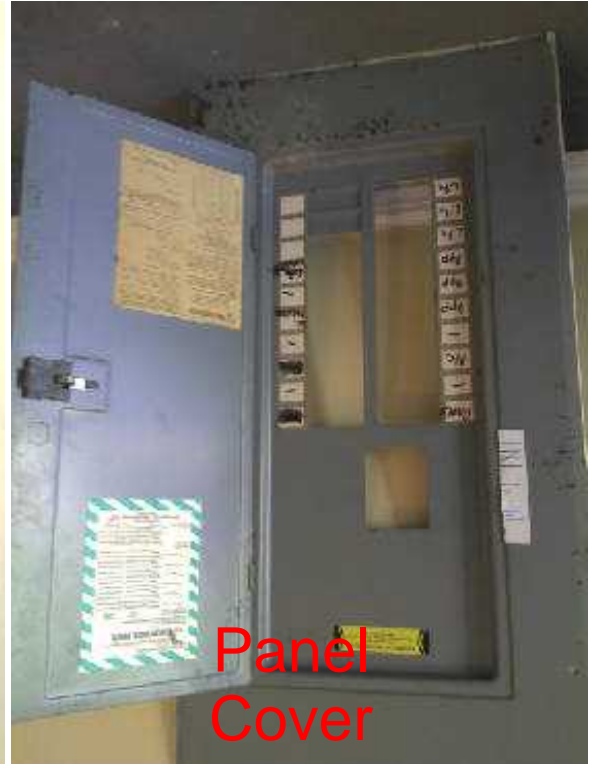
Panel  
Cover

1. Service Size Amps: 150 Volts:
2. ☒ ☐ ☐ ☐ ☐ Service: Aluminum

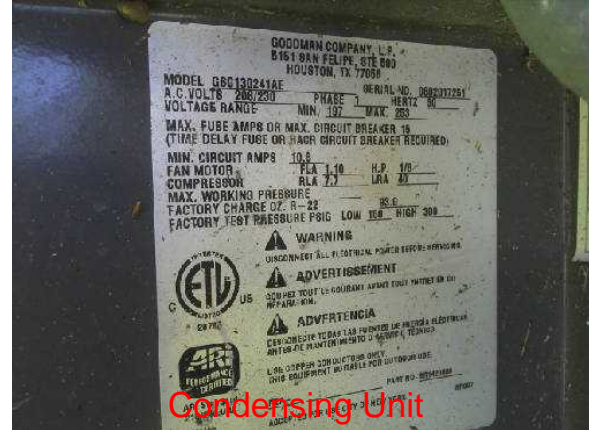
### Heat Pump AC System

1. ☒ ☐ ☐ ☐ ☐ A/C System Operation: Appears serviceable

2. ☒ ☐ ☐ ☐ ☐ Condensate Removal: PVC
3. ☒ ☐ ☐ ☐ ☐ Exterior Unit: Pad mounted
4. Manufacturer: Goodman
5. Model Number: G86130241AE Serial Number: 0802017251
6. Area Served: Whole building Approximate Age: 11 yrs
7. Fuel Type: 110-120 VAC Temperature Differential: 10
8. Type: Heat pump Capacity: 2 Ton
9. ☐ ☐ ☒ ☐ ☐ Visible Coil:
10. ☒ ☐ ☐ ☐ ☐ Refrigerant Lines: Serviceable condition
11. ☒ ☐ ☐ ☐ ☐ Electrical Disconnect: Breaker disconnect
12. ☒ ☐ ☐ ☐ ☐ Exposed Ductwork: Insulated flex
13. ☐ ☐ ☒ ☐ ☐ Blower Fan/Filters:
14. ☒ ☐ ☐ ☐ ☐ Thermostats: Individual

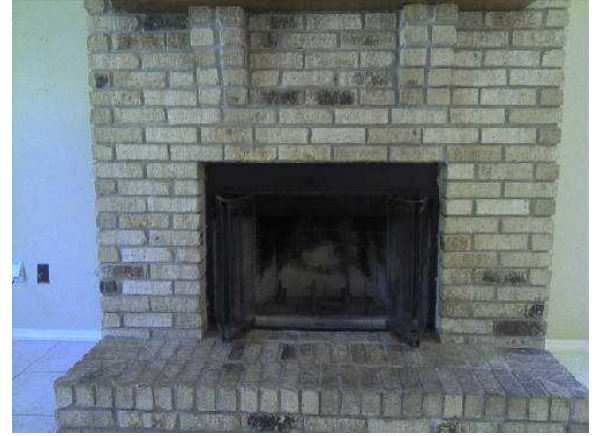
1. ☒ ☐ ☐ ☐ ☐ Fireplace Construction: Brick

2. Type: Wood burning  
3. ☒ ☐ ☐ ☐ ☐ Fireplace Insert: Standard  
4. ☒ ☐ ☐ ☐ ☐ Smoke Chamber: Brick  
5. ☒ ☐ ☐ ☐ ☐ Flue: Metal  
6. ☒ ☐ ☐ ☐ ☐ Damper: Metal  
7. ☒ ☐ ☐ ☐ ☐ Hearth: Raised
